**Flood Control Project Maintenance
Levee Inspections**

Maintenance Issue Types Only, Levee Inspection Report By Mile - Fall 2016

Reclamation District No. 0900 West Sacramento

Waterway	Bank	Unit Miles	Inspection Start/End	Inspector
Unit No. 01 Sacramento River	Right	7.70	10/06/2016 10/06/2016	Pavel Kazi

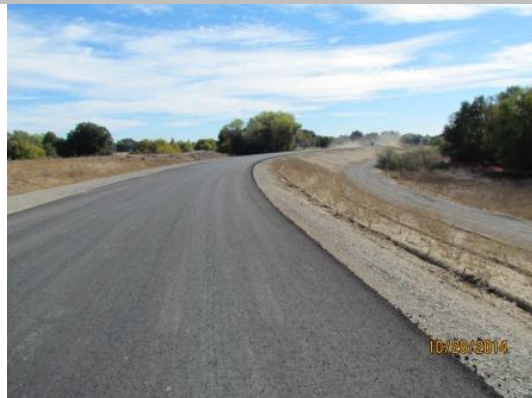
Photo 1 of 1 : FA_2016_RD0900_230_1_20160823_00001.jpg

LM Start	2.00	Rating **	A/W	Issue No.	1
LM End	2.25	Issue Type +	Ma	Location *	CR
Category	Earthen Levee			GPS Latitude/Longitude	
				Start	End
Item	Vegetation			38.559202 °	38.555462 °
				-121.517707 °	-121.516297 °
DWR ID	DWR_RD0900_01_s_2012_1				
Comment Code					
V2 : Remove the wild growth other than native grasses from the levee slopes.					
Inspector Comment					
USACE has started to construct a setback levee in this area and has taken control of this portion of the levee.

View of the new setback levee looking downstream during fall 2014 inspection.

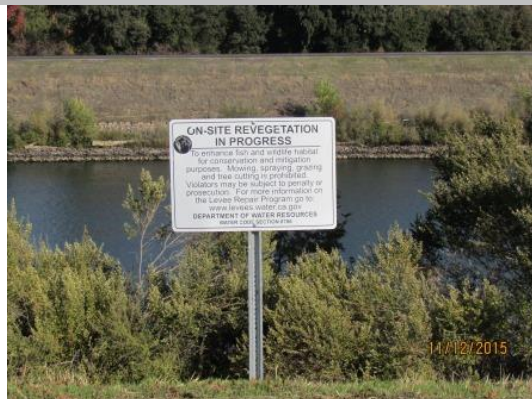
Photo 1 of 1 : FA_2016_RD0900_230_17_20160823_00011.jpg

LM Start	2.26	Rating **	A/W	Issue No.	17
LM End	3.72	Issue Type +	Ma	Location *	WS
Category	Earthen Levee			GPS Latitude/Longitude	
				Start	End
Item	Vegetation			38.555304 °	38.536946 °
				-121.516127 °	-121.519774 °
DWR ID	DWR_RD0900_01_s_2012_17				
Comment Code					
V8 : Environmental Requirements.					
Inspector Comment

View of the DWR environmental mitigation site.

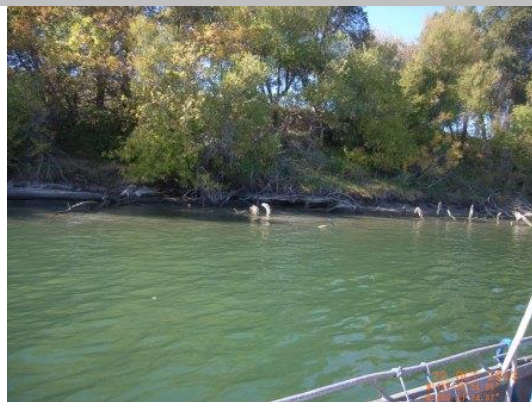
Photo 1 of 1 : FA_2016_RD0900_230_10_20160823_00008.jpg

LM Start	2.35	Rating **	M	Issue No.	10
LM End	2.47	Issue Type +	Ma	Location *	WS
Category	Supplemental			GPS Latitude/Longitude	
				Start	End
Item	2015 USACE Erosion Survey, DRAFT			38.554277 °	38.552504 °
				-121.515263 °	-121.514752 °
DWR ID	DWR_RD0900_01_s_2016_10				
Comment Code					
Inspector Comment					
2007 - Have good berm width with minor toe erosion. Close to the levee toe protection, but levee slope is steep. 2011 - New large erosion pocket. 2012 - Minor new erosion at the toe. 2015: No observed changes. [2015 Site ID: SAC_56-7_R]

USACE 2013 Photo #1

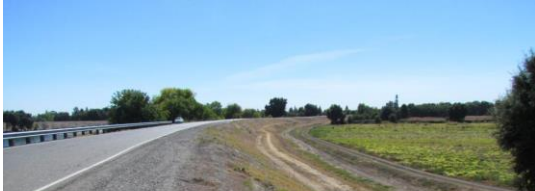
Photo 1 of 1 : FA_2016_RD0900_230_61_20161010_00031.jpg

View of the landside of the levee looking downstream. Fall 2016

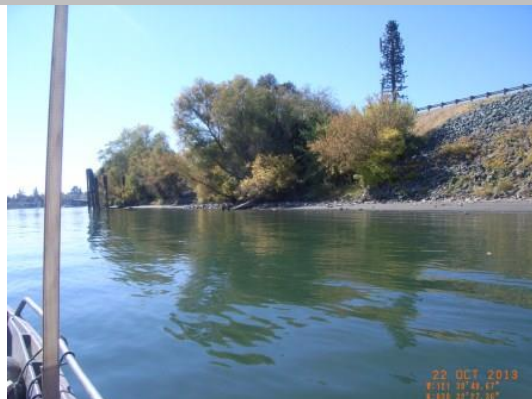
Photo 1 of 1 : FA_2016_RD0900_230_2_20160823_00002.jpg

LM Start	3.27	Rating **	M	Issue No.	2
LM End	3.48	Issue Type +	Ma	Location *	WS
Category	Supplemental			GPS Latitude/Longitude	
				Start	End
Item	2015 USACE Erosion Survey, DRAFT			38.541246°	38.538689°
				-121.513561°	-121.515916°
DWR ID	DWR_RD0900_01_s_2016_2

2008 - Erosion into levee toe. Over steepened levee slope, worst at the upstream end. 2009 - Near vertical banks from rotational slumping, hidden by vegetation. 2010 - Boat sinking more, may be causing eddy scour around it. Difficult to see the vertical slumps due to dense vegetation. 2011 - Minor new erosion at the toe. The paddleboat that was sitting at this site for years has been removed. 2012 - Site extended upstream due to additional erosion. 2015: No observed changes. [2015 Site ID: SAC_55-7_R]

USACE 2013 Photo #1

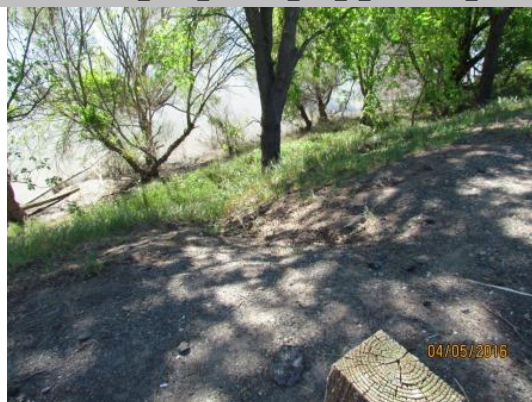
Photo 1 of 2 : FA_2016_RD0900_230_4_20160823_00003.jpg

LM Start	3.41	Rating **	M	Issue No.	4
LM End	3.41	Issue Type +	Ma	Location *	WS
Category	Earthen Levee			GPS Latitude/Longitude	
				Start	End
Item	Slope Stability			38.539770 °	38.539770 °
				-121.515276 °	-121.515276 °
DWR ID	DWR RD0900 01 s 2014 4

Updated picture of the slope instability on the waterside of the levee looking downstream during spring 2016 inspection.

S2 : Repair the levee slope damaged by foot traffic and prevent access where possible.

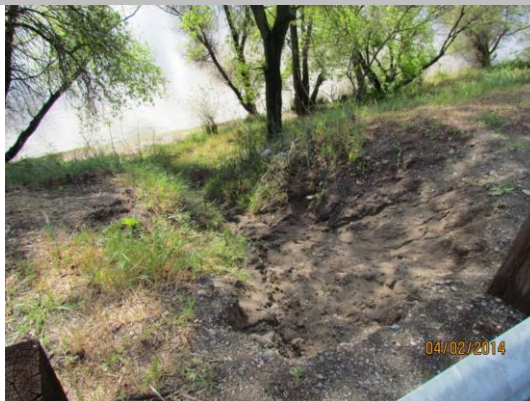
Photo 2 of 2 : FA_2016_RD0900_230_4_20160823_00004.jpg

LM Start	3.41	Rating **	M	Issue No.	4 (cont)	
LM End	3.41	Issue Type +	Ma	Location *	WS	
Category	Earthen Levee			GPS Latitude/Longitude		
				Start		End
Item	Slope Stability			38.539770 °		38.539770 °
				-121.515276 °		-121.515276 °
DWR ID	DWR_RD0900_01_s_2014_4					
Comment Code						
S2 : Repair the levee slope damaged by foot traffic and prevent access where possible.						
Inspector Comment

A slope instability was found on the waterside slope of the levee looking downstream.

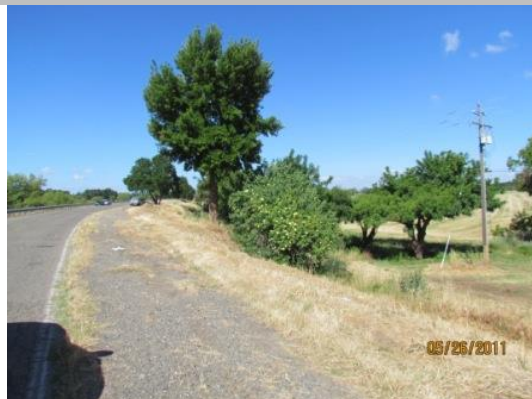
Photo 1 of 1 : FA_2016_RD0900_230_958_20160823_00024.jpg

LM Start	5.51	Rating **	M	Issue No.	958
LM End	5.51	Issue Type +	Ma	Location *	LS
Category	Earthen Levee			GPS Latitude/Longitude	
				Start	End
Item	Vegetation			38.518988°	38.518988°
				-121.527738°	-121.527738°
DWR ID	DWR_RD0900_01_s_2012_958				
Comment Code					
V4 : Elderberries are blocking visibility and flood fight capability.					
Inspector Comment					
Elderberries are partially blocking the visibility.

Elderberry on the landside of the levee. The picture was taken from the crown looking downstream.

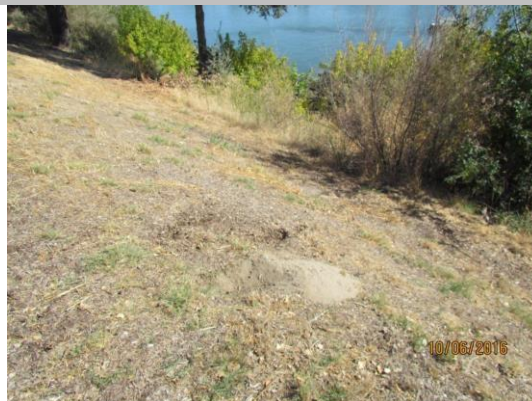
Photo 1 of 1 : FA_2016_RD0900_230_62_20161010_00032.jpg

LM Start	6.87	Rating **	M	Issue No.	62
LM End	6.87	Issue Type +	Ma	Location *	WS
Category	Earthen Levee			GPS Latitude/Longitude	
				Start	End
Item	Animal Control			38.514974 °	38.514974 °
				-121.552041 °	-121.552041 °
DWR ID	DWR_RD0900_01_f_2016_62				
Comment Code					
A3 : No rodents visible, but rodent burrows visible; need to backfill and compact or grout burrows.					
Inspector Comment

View of a rodent hole on the waterside of the levee.

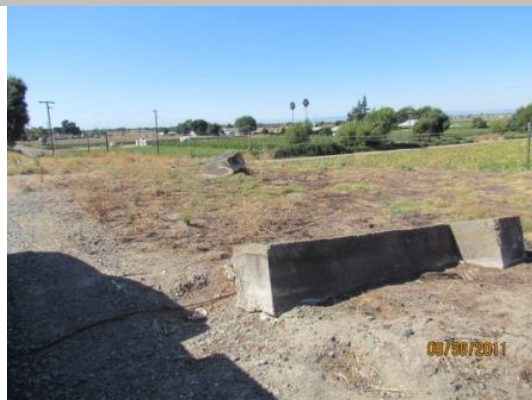
Photo 1 of 1 : FA_2016_RD0900_230_343_20160823_00023.jpg

LM Start	7.10	Rating **	M	Issue No.	343
LM End	7.10	Issue Type +	Ma	Location *	LS
Category	Earthen Levee			GPS Latitude/Longitude	
				Start	End
Item	Encroachments			38.512642 °	38.512642 °
				-121.554881 °	-121.554881 °
DWR ID	DWR_RD0900_01_s_2012_343				
Comment Code					
DE : Debris					
Inspector Comment					
Concrete debris from old railroad track.

Concrete debris from old rail road track was found on the landside of the levee looking upstream.

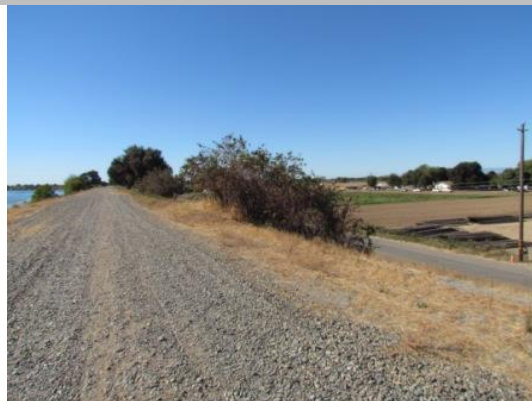
Photo 1 of 1 : FA_2016_RD0900_230_8_20160823_00006.jpg

LM Start	7.21	Rating **	M	Issue No.	8
LM End	7.21	Issue Type +	Ma	Location *	LS
Category	Earthen Levee			GPS Latitude/Longitude	
				Start	End
Item	Vegetation			38.511104 °	38.511104 °
				-121.555664 °	-121.555664 °
DWR ID	DWR_RD0900_01_s_2012_8				
Comment Code					
V4 : Elderberries are blocking visibility and flood fight capability.					
Inspector Comment					
Elderberries are partially blocking the visibility.

An elderberry bush was found on the landside of the levee looking downstream.

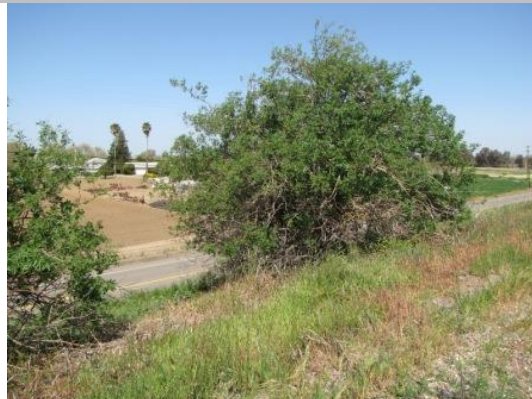
Photo 1 of 1 : FA_2016_RD0900_230_7_20160823_00005.jpg

LM Start	7.25	Rating **	M	Issue No.	7
LM End	7.25	Issue Type +	Ma	Location *	LS
Category	Earthen Levee			GPS Latitude/Longitude	
				Start	End
Item	Vegetation			38.510613 °	38.510613 °
				-121.555969 °	-121.555969 °
DWR ID	DWR_RD0900_01_s_2012_7				
Comment Code					
V4 : Elderberries are blocking visibility and flood fight capability.					
Inspector Comment					
Elderberries are partially blocking the visibility.

View of elderberries on the landward slope looking upstream.

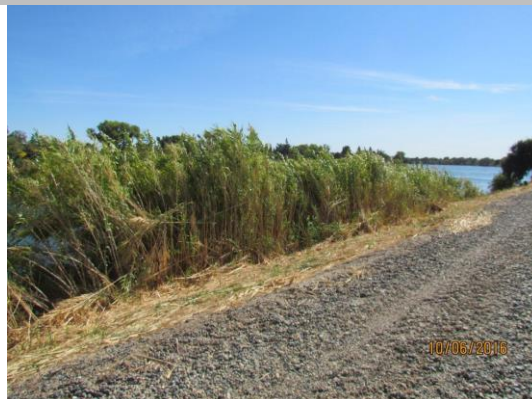
Photo 1 of 2 : FA_2016_RD0900_230_59_20161010_00033.jpg

LM Start	7.47	Rating **	M	Issue No.	59
LM End	7.47	Issue Type +	Ma	Location *	WS
Category	Earthen Levee			GPS Latitude/Longitude	
				Start	End
Item	Vegetation			38.507648°	38.507648°
				-121.557571°	-121.557571°
DWR ID	DWR_RD0900_01_f_2012_59				
Comment Code					
V2 : Remove the wild growth other than native grasses from the levee slopes.					
Inspector Comment					
Arrundo growth on the waterside slope of the levee.

Updated picture of the arundo on the waterside of the levee during fall 2016 inspection.

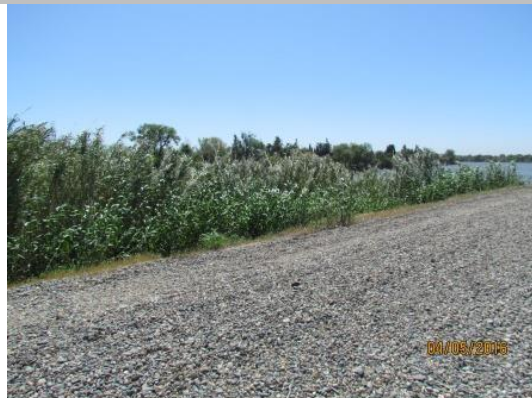
Photo 2 of 2 : FA_2016_RD0900_230_59_20160823_00015.jpg

Updated picture of the arundo on the waterside of the levee during spring 2016 inspection.

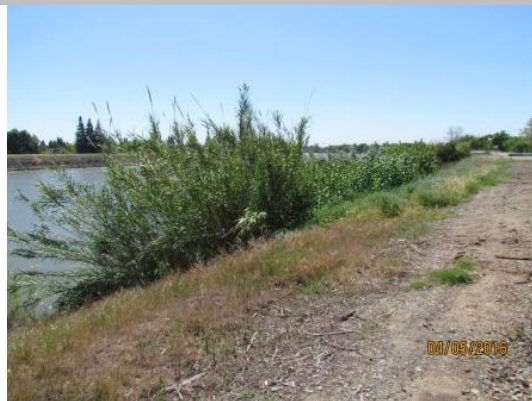
Photo 1 of 2 : FA_2016_RD0900_230_15_20160823_00009.jpg

LM Start	7.78	Rating **	M	Issue No.	15
LM End	7.78	Issue Type +	Ma	Location *	WS
Category	Earthen Levee			GPS Latitude/Longitude	
				Start	End
Item	Vegetation			38.503490°	38.503490°
				-121.559770°	-121.559770°
DWR ID	DWR_RD0900_01_f_2013_15				
Comment Code					
V2 : Remove the wild growth other than native grasses from the levee slopes.					
Inspector Comment					
Arrundo on the waterside

Updated picture of the arundo on the waterside of the levee during spring 2016 inspection.

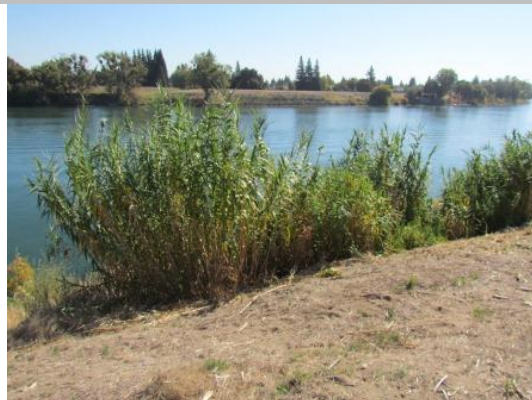
Photo 2 of 2 : FA_2016_RD0900_230_15_20160823_00010.jpg

View of arundo on the waterside of the levee looking downstream.

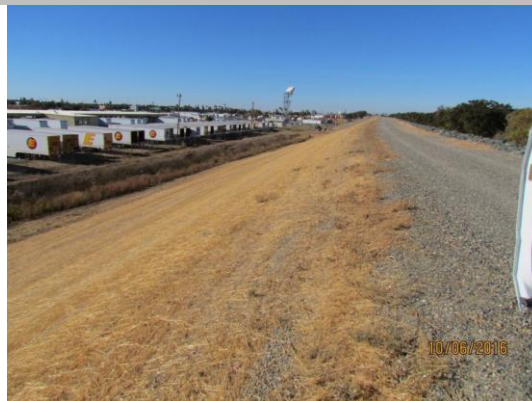
Photo 1 of 1 : FA_2016_RD0900_231_44_20161010_00044.jpg

LM Start	0.09	Rating **	A	Issue No.	44
LM End	0.09	Issue Type +	Ma	Location *	LS
Category	Earthen Levee			GPS Latitude/Longitude	
				Start	End
Item	Vegetation			38.580961 °	38.580961 °
				-121.568222 °	-121.568222 °
DWR ID	DWR_RD0900_02_f_2016_44				
Comment Code					
V1 : Control annual grass and weeds on the levee slopes and easements.					
Inspector Comment					
Acceptable vegetation.

View of the landside of the levee looking downstream. Fall 2016

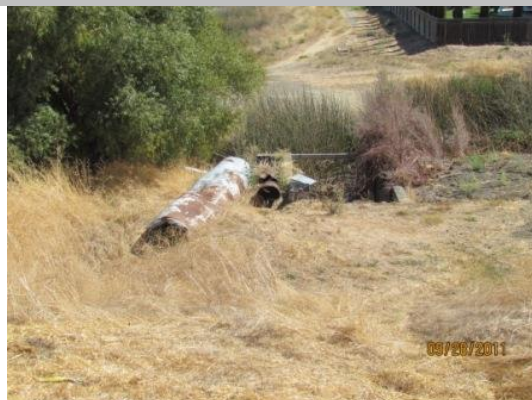
Photo 1 of 1 : FA_2016_RD0900_231_15_20160823_00003.jpg

LM Start	3.26	Rating **	M	Issue No.	15
LM End	3.26	Issue Type +	Ma	Location *	LS
Category	Earthen Levee			GPS Latitude/Longitude	
				Start	End
Item	Encroachments			38.540943 °	38.540943 °
				-121.582280 °	-121.582280 °
DWR ID	DWR_RD0900_02_s_2012_15				
Comment Code					
PI : Pipe					
Inspector Comment					
Recently removed waterward pump. Some pipe, equipment and debris remain.

Abandon pipes and debris was found on the landside of the levee looking upstream.

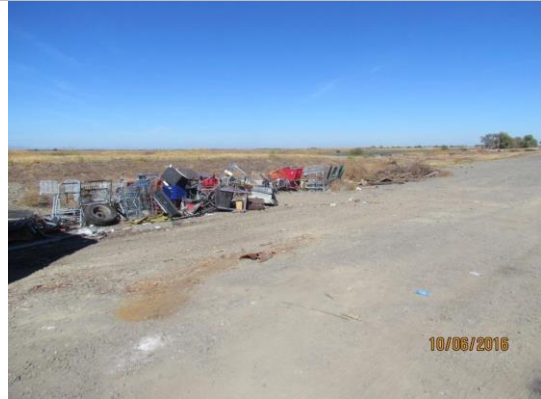
Photo 1 of 1 : FA_2016_RD0900_231_45_20161010_00046.jpg

LM Start	5.04	Rating **	M	Issue No.	45
LM End	5.04	Issue Type +	Ma	Location *	LS
Category	Earthen Levee			GPS Latitude/Longitude	
				Start	End
Item	Encroachments			38.515091 °	38.515091 °
				-121.582178 °	-121.582178 °
DWR ID	DWR_RD0900_02_f _ 2016_45				
Comment Code					
DE : Debris					
Inspector Comment

View of debris on the landside shoulder of the levee looking upstream.
